## Chapter 9

### Post-Closure Maintenance and Site End Use

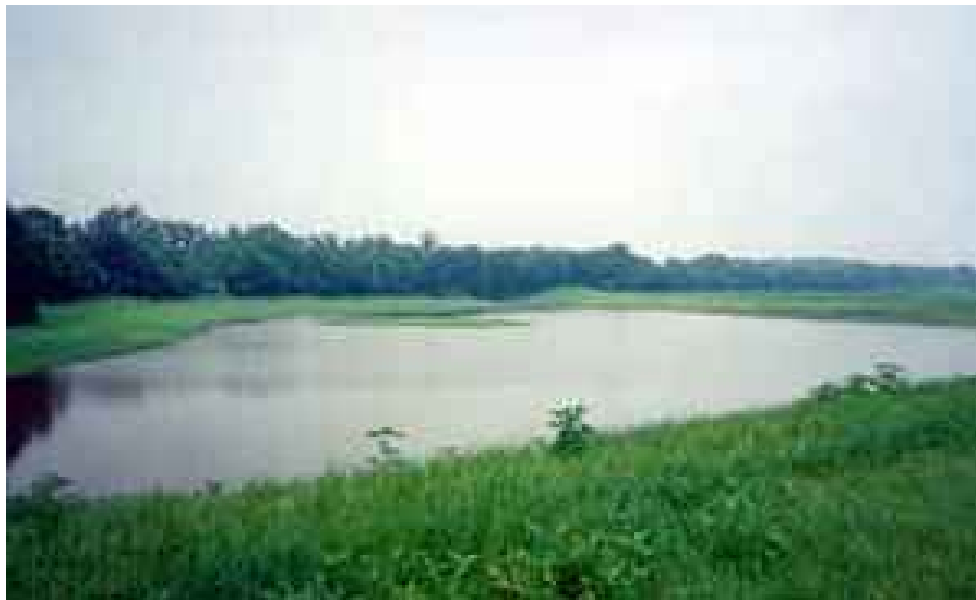
**Figure 9-1. Constructed Wetlands at Bowers Landfill Site.**

As described by EPA (1999a, 1999b), the 5-ha Bowers Landfill site was located in a former rock quarry within the Scioto River floodplain in central Ohio. Municipal, chemical, and industrial wastes were disposed in the landfill. Until the remedy was constructed the site was flooded an average of 29 days/yr, and contaminants from the site were carried to groundwater and the river. The remedy included removing surface debris and sediments, constructing a cover system that included a CCL barrier and gas collection system over the landfill, and creating 3-ha of wetlands between the landfill and the river. The wetlands not only provide a protective buffer between the landfill and river, but also provide habitat for numerous species of plants, birds, and other wildlife.

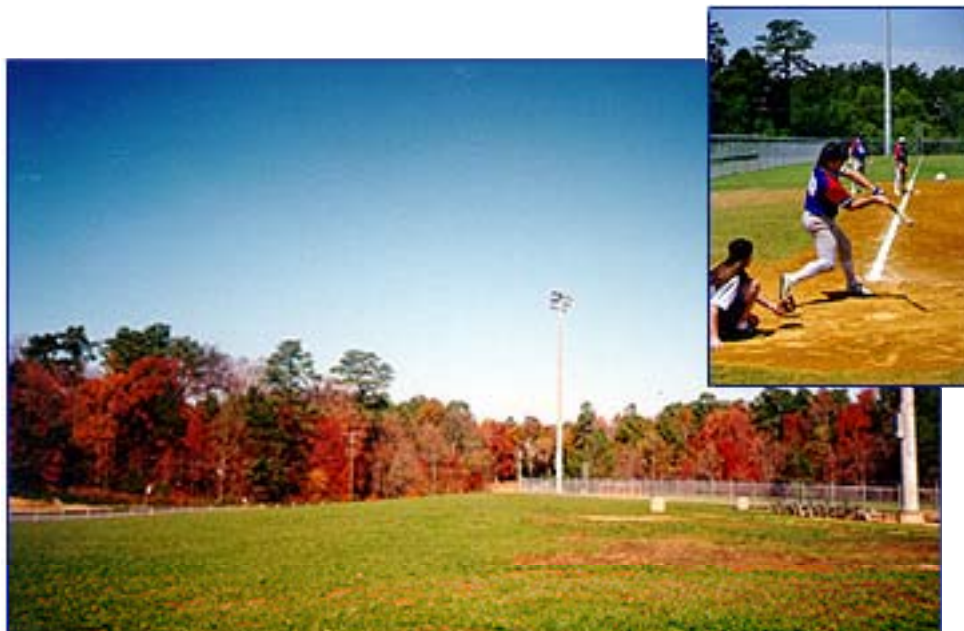
**Figure 9-2. Softball Fields at Chisman Creek Superfund Site (from EPA, 1999c).**

The site, plus some adjacent property, was developed into two sports parks, with two lighted softball fields, four soccer fields, restrooms, vending facilities, equipment storage facilities, and a parking area (Figure 9-2). The cover system was engineered to serve as a foundation for the park facilities and graded to accommodate park structures. The cover system design consists of, from top to bottom:

- 0.15-m thick vegetated topsoil surface/protection layer;
- 0.15-m thick sand drainage layer;
- 0.3-m thick CCL; and
- 0.3-m thick soil/ash mixture.

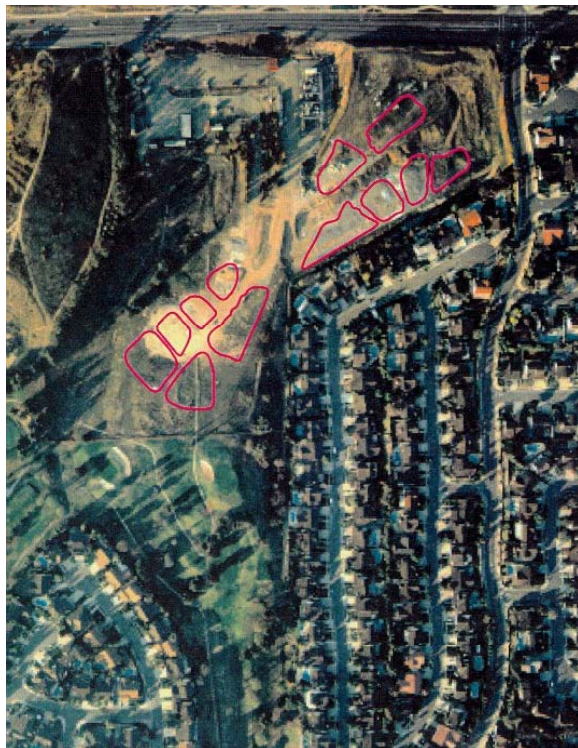
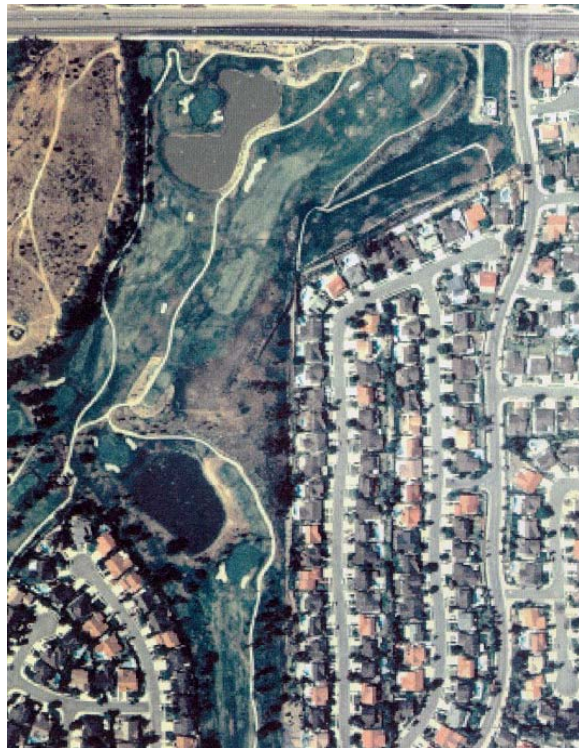
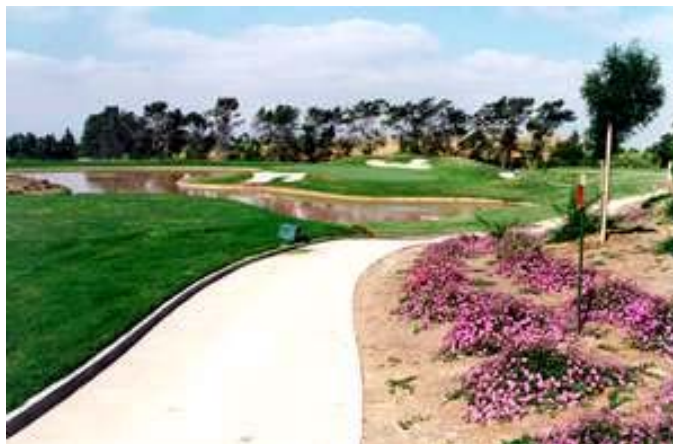
**Figure 9-3. McColl Superfund Site: (a) Before Closure; (b,c) After Development as a Golf Course and Wildlife Sanctuary ((c) was downloaded from an EPA website at [http://www.epa.gov/superfund/programs/recycle/briefs/ca\\_brief.htm](http://www.epa.gov/superfund/programs/recycle/briefs/ca_brief.htm)).**

As described by Collins et al. (1998), the 8.8-ha McColl Superfund site is located in Fullerton, California and includes 12 unlined pits of sludges and other wastes from production of high-octane aviation fuel (Figure 9-3(a)). In the 1950s and 1960s, three pits were covered with diesel-oil based drilling mud and six pits were covered with soil to control odor and gaseous emissions. The site was placed on the NPL in 1982. The remedy for the site was designed around its end use as part of the Los Coyotes Golf Course and wildlife sanctuary (Figures 9-3(b) and (c)). The remedy includes a multi-component soil and geosynthetic cover system designed to control infiltration and emissions of thiophene compounds, retaining walls to stabilize steep slopes adjacent to the pits, and a soil-bentonite slurry wall. In areas that had been covered with soft drilling muds, a lightweight geocell-reinforced cover system was used. Beneath the golf course, the cover system was geogrid reinforced and included a cobble protection layer to minimize the potential for human intrusion. For both conditions, the cover system included an HDPE GM/GCL barrier underlain by a sand gas collection/foundation layer.

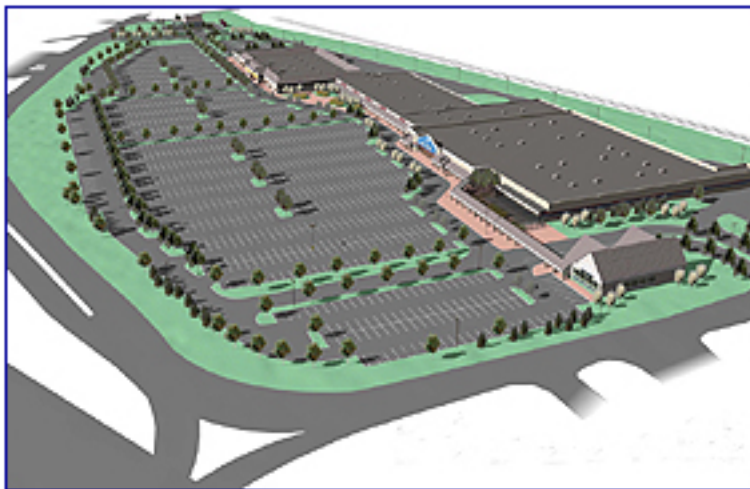
**Figure 9-4. Conceptual Drawing of Future Shopping Center at Raymark Superfund Site (EPA, 1999d).**

The proposed end-use for the Raymark Superfund site is a 3-ha retail shopping center (Figure 9-4). Prior to construction of the cover system, the site was improved to enhance its geotechnical properties. In-place soils and waste were stabilized using dynamic compaction or surcharging, and peat deposits were dewatered using wick drains. A 0.2-ha platform foundation for the shopping center has been constructed. The platform is supported by 277 30-m long piles that penetrate the cover system.

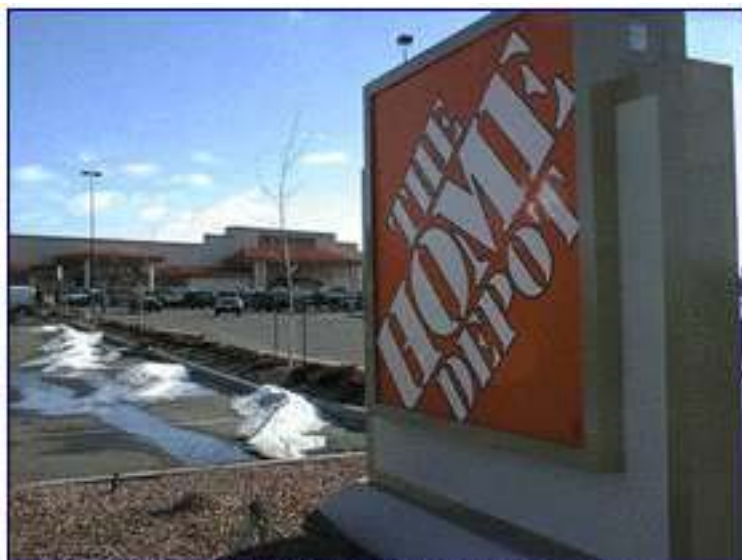
**Figure 9-5. Part of the Denver Radium Superfund Site was Developed with a Retail Store (EPA, 1999e).**

The remedy for OU 9 consisted of excavating radioactive materials found at the site and shipping them to an offsite disposal facility and relocating 13,000 m<sup>3</sup> of metals-contaminated soils to four unlined containment cells covered with asphaltic concrete. The primary risks to human health and the environment posed by the soils are related to the ingestion or inhalation of the metals. Since the metals in the soils are only slightly soluble, percolation of water through the soils is not likely to cause the metals to migrate. Thus, the cover systems for the four cells were designed to minimize contact with the waste, rather than to minimize percolation. The remedy was developed concurrently with the design of the site reuse. The site has been developed with a large retail store and parking lot (Figure 9-5). The uncontaminated spaces between the four containment cells were used for utility corridors, and the asphaltic concrete cover systems were incorporated into the parking lot. The store, itself, was constructed on uncontaminated soil.
